# Residual Ridge Under Long Standing Bridge

Series A, Number 5

JOHN LUPOVICI, DDS. *New York, New York*

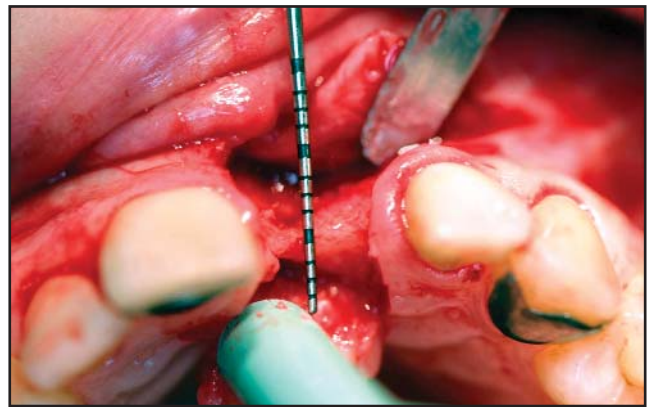
*FIG. 2: Exposure of ridge defect, showing as little as 1mm ridge thickness on the mesial aspect of implant site.*

A 47-year-old patient presented with a request for implant placement in the site of #9, long standing Maryland Bridge. The site was lacking ridge width to support implant placement.

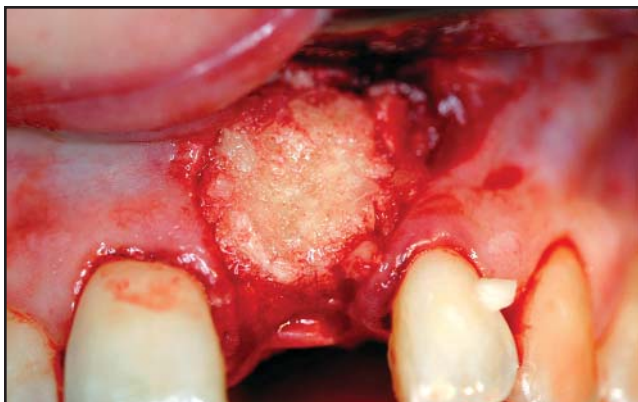
*FIG. 3: Placement of 0.5cc Regenaform® in prepared graft site. The area was lightly decorticated and cleaned of all tissue tags and remnants prior to placement.*

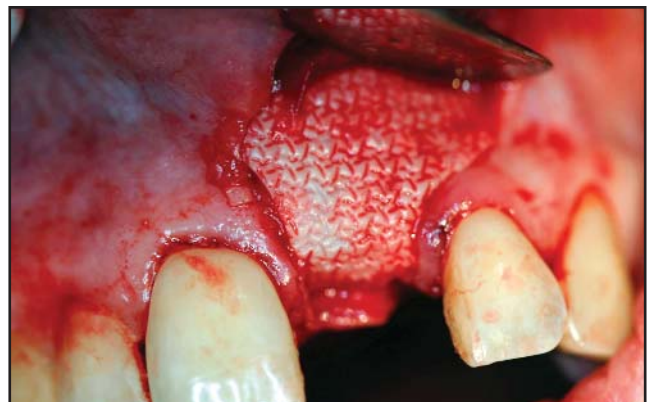
*FIG. 4: Ossix® collagen membrane placement*

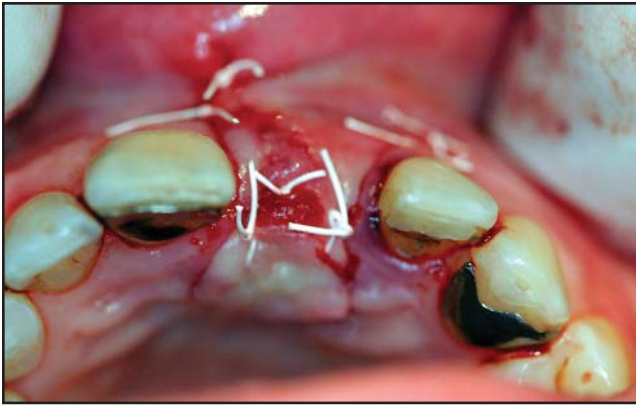
*FIG. 5: Flap closure with non-resorbable Gore-Tex® 4.0 suture.*

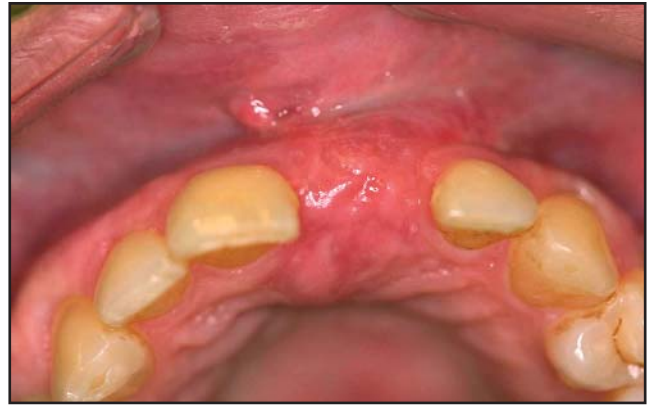
*FIG. 6: 4 1/2 month pre-re-entry of site.*

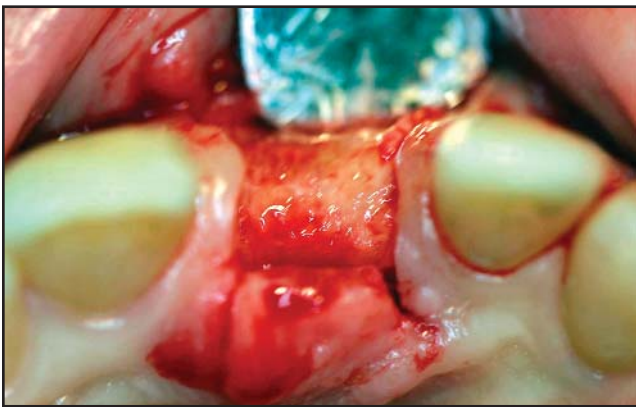
*FIG. 7: 4 1/2 month exposure of ridge.*

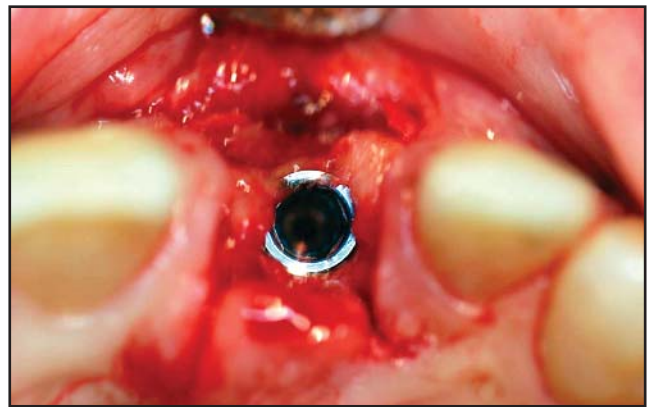
*FIG. 8: 4mm Certain® implant fixture placement post-op.*

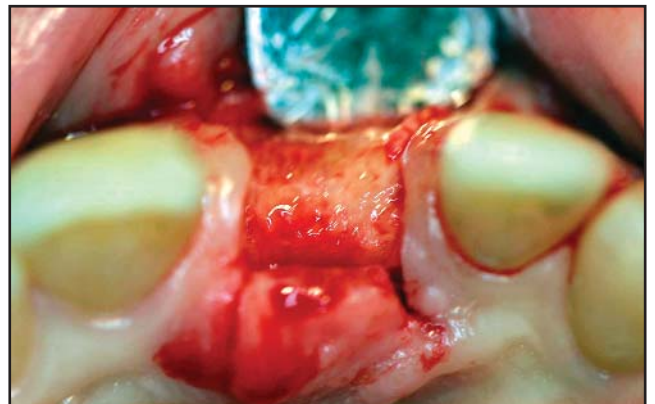
*FIG. 10: Post-op 4 1/2 months.*
