*****URGENT DEAR HEALTHCARE PROFESSIONAL COMMUNICATION*****

To: Surgeons, Hospitals, Health care professionals
Description: Exactech Connexion GXL acetabular polyethylene liners

Section 1- Introduction

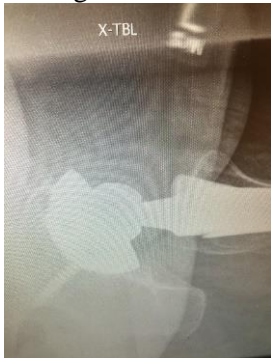
1. Significant combined anteversion with anterior edge loading of the femoral head on the acetabular liner

9. When the combined anteversion and/or combined abduction of the acetabular and femoral components is high, edge loading and accelerated wear can present

It is also noted that the index THA in many of the patients in these series was performed through a direct anterior approach. It has been reported that the direct anterior approach to the hip can lead to supranormal combined anteversion of the acetabular and femoral components with subsequent anterior edge loading[16], [18], [19].

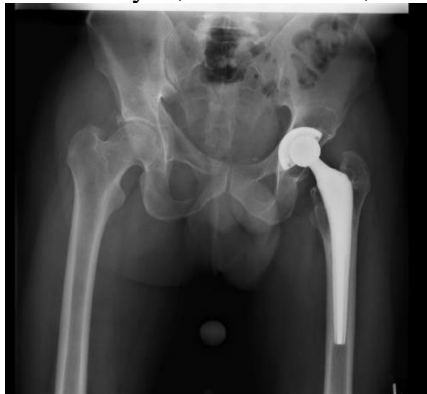
2. Osteolysis, radiolucencies, and/or asymmetric wear

- c. Functional sitting and standing x-rays, if possible
13. For patients with x-ray signs of either:
 - a. Edge loading (by x-ray)
 - b. Early lysis
 - c. Exactech recommends either repeat follow-up in 6-12 months, CT scan imaging (if considered clinically necessary to assess lytic lesions), and potentially revision to the next generation Exactech Vitamin E, HXLPE if possible, based on the surgeon's judgment.

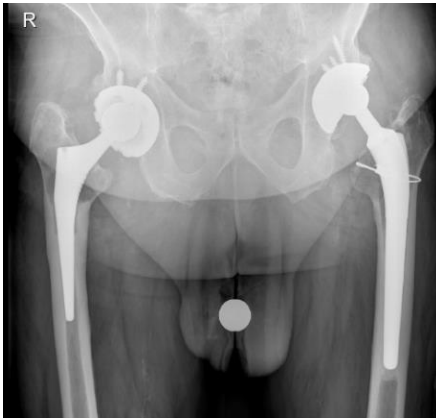
3. Significant vertical/abduction positioning of the acetabular component

Additionally, in these series was a tendency for early and accelerated wear to be demonstrated in patients who had cup positions toward cups at upper ends of Lewinnek abduction/anteversion, and a tendency towards younger, (<70 yrs.) more active patients. Of note, these papers did not measure the functional pelvic position of the acetabular components. These papers used the Lewinnek safe zone concept on static x-rays to determine the relative appropriateness of cup position[1], [12], [13].
